**Nortel Communication Server 1000**

# **Communication Server 1000E**

## **Maintenance**

Document Number: 553-3041-500

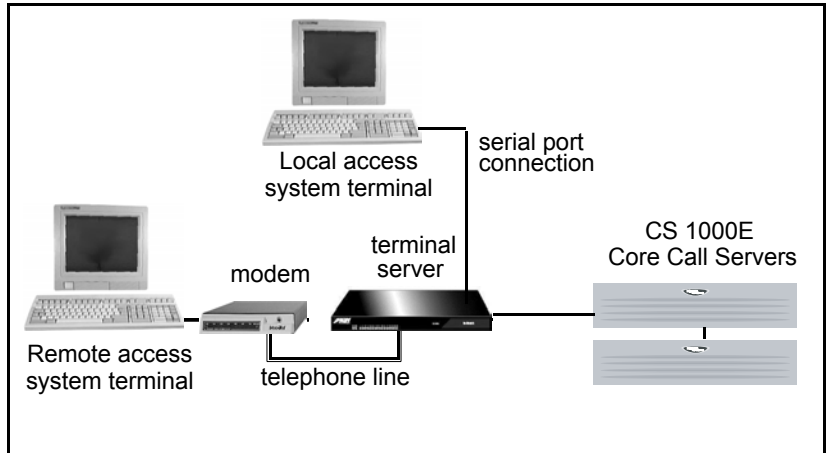
**Figure 1**  
**CS 1000E local and remote access system terminals**

Figure 1 shows a typical system terminal configuration to the Call Servers.

With the CS 1000E, a system terminal can also connect directly to the Call Server, Signaling Server, Media Cards, and Media Gateway 1000Es (MG 1000Es).

When a system terminal is installed directly on the Call Server, it connects to the Com 1 port.

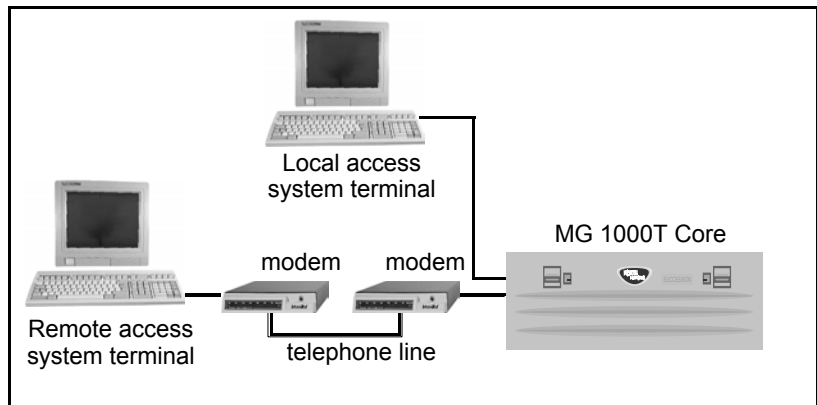
**Figure 2**  
**MG 1000T local and remote access system terminals**

Figure 2 shows a typical system terminal configuration to the MG 1000T Core.

With the MG 1000T platform, a system terminal can also connect to the MG 1000T Expansion, Signaling Server, and Media Cards.

When a system terminal connects to an MG 1000T Expansion, it connects to the SSC through a rear SDI port, in the same manner as the MG 1000T Core.

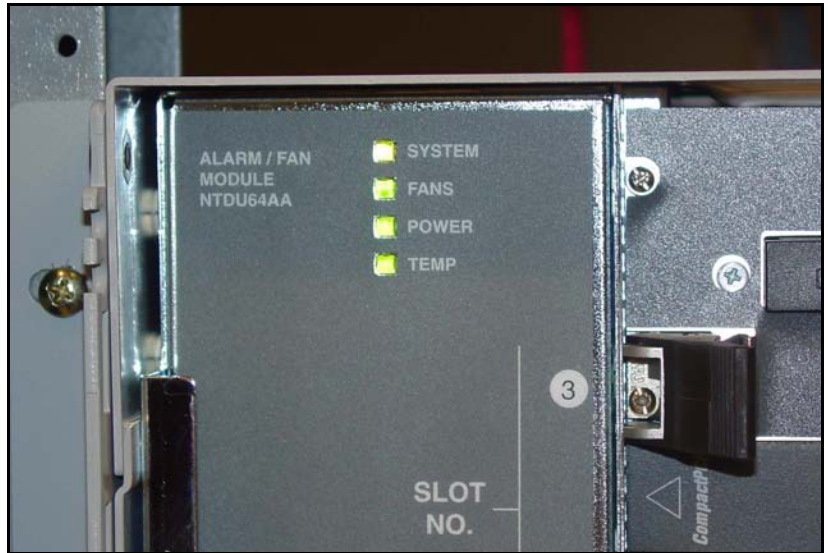
**Figure 3**  
**Alarm/fan module status LEDs**

Figure 3 shows the alarm/fan module green status LEDs during normal operations.

The system LED consolidates the status of the other three LEDs. That is, if the fans, power, and temperature are all within normal operating parameters, then the system LED is green. If any of the three other LEDs is red, indicating trouble, then the system LED also appears red.

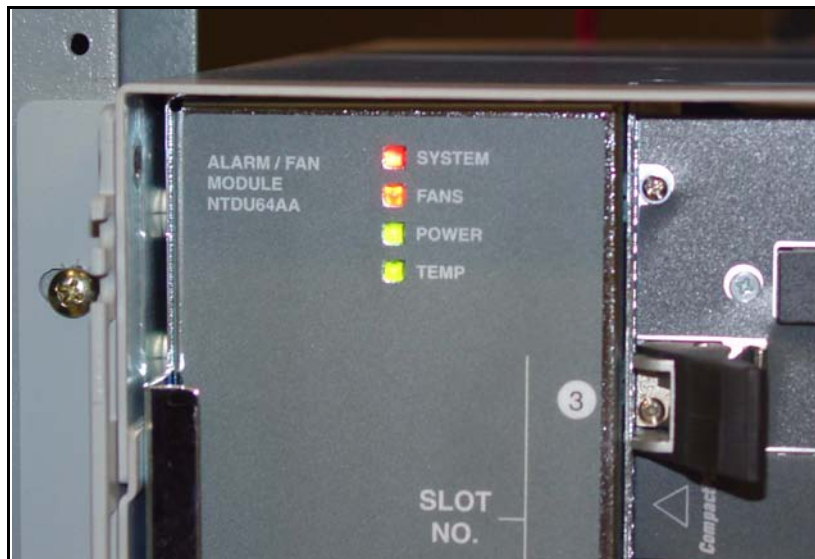
**Figure 4**  
**Fan trouble LEDs**

Figure 4 shows the alarm/fan Module LEDs indicating fan trouble.

As the system LED shows the status of the other three LEDs, it is used to determine the overall status of the Call Server. It is visible through a light pipe in the Call Server front cover.

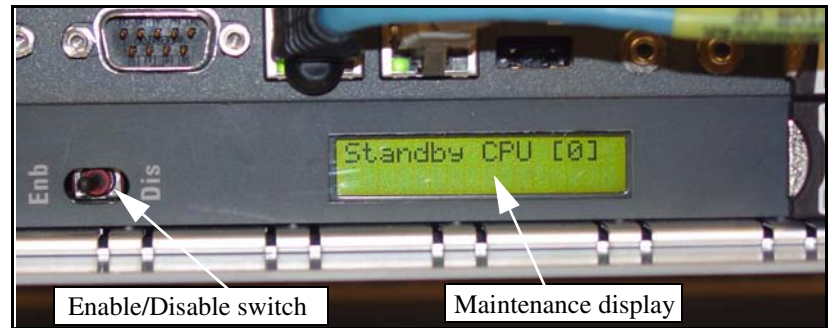
**Figure 5**  
**System Utility card display for standby Call Server**

The System Utility card maintenance display indicates the status of the Call Server, either active or standby. The display also provides an indication of normal and fault conditions as well as the progress of software upgrades and backups.

Figure 5 shows the System Utility card display for a standby Call Server.

Figure 5 also shows the location of the Enable/Disable (Enb/Dis) switch on the card. This switch enables and disables the hardware for that card.

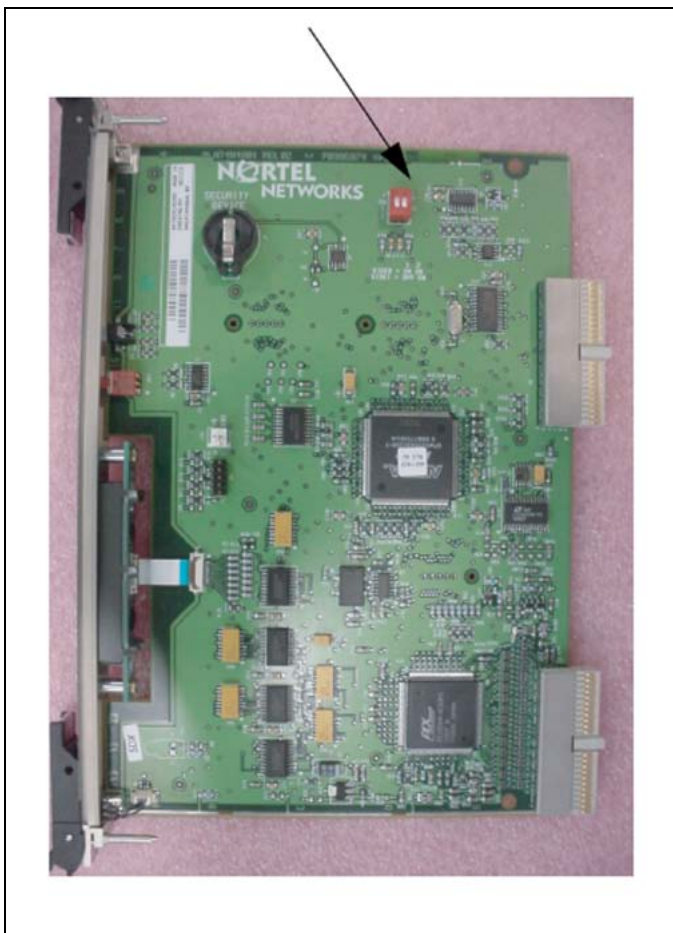
**Figure 6**  
**Core Module ID switch**

Confirm that these settings match the identification labels for the module into which they will be installed. See Table 2 on [page 37](#) and Figure 6.

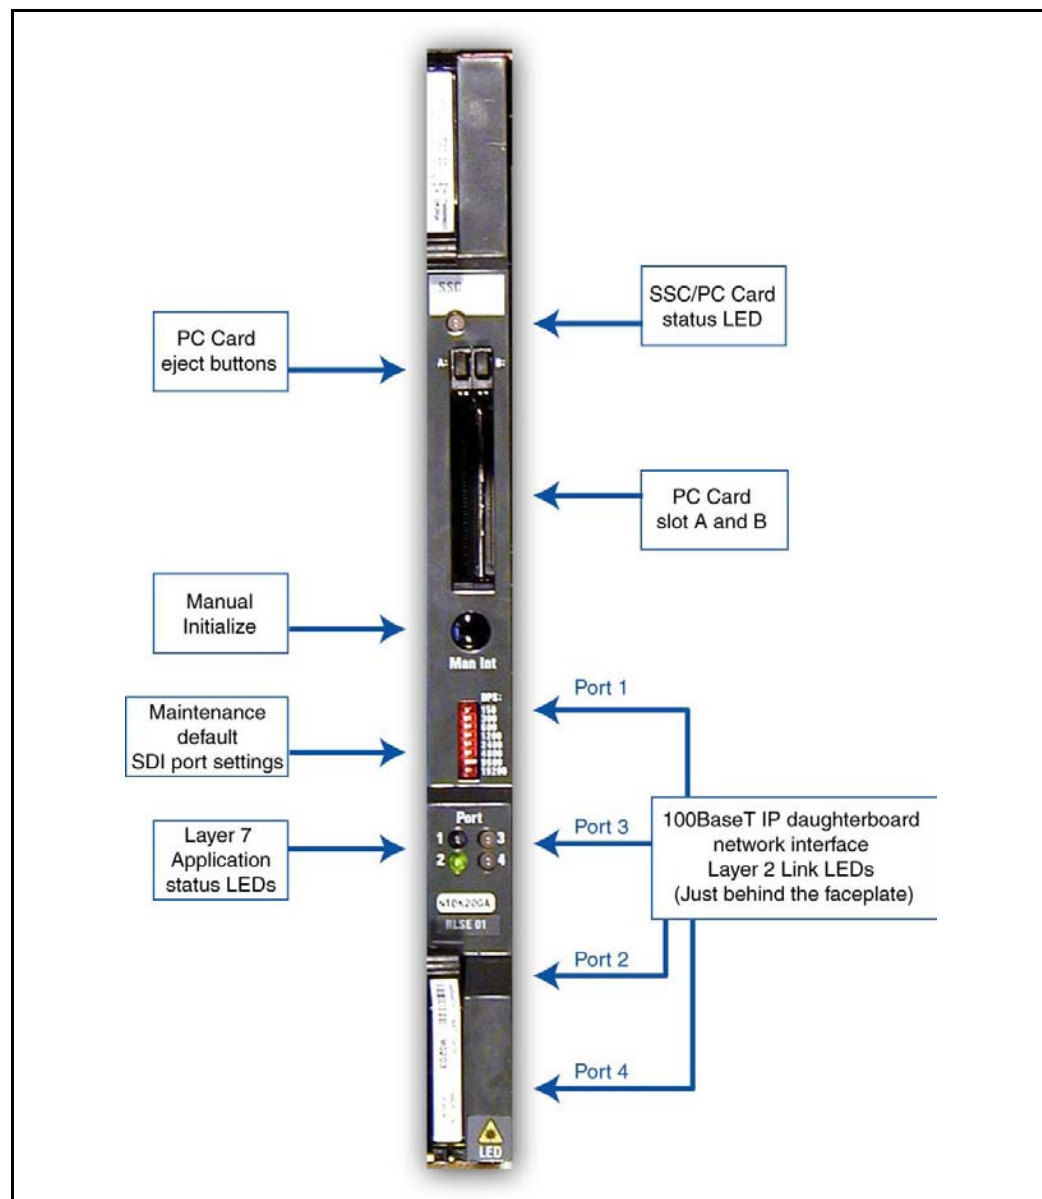
**Figure 7**  
**SSC card faceplate**

Figure 7 on [page 49](#) shows the SSC card faceplate features.

Similar to the Init button on the CS 1000E Core Call Server, the manual initialize (Man Int) button on the SSC card starts the Initialize program. The Initialize program can clear some equipment faults. It then rebuilds call-dependent data, and generates system messages indicating the status of the system. This process is called an initialization.

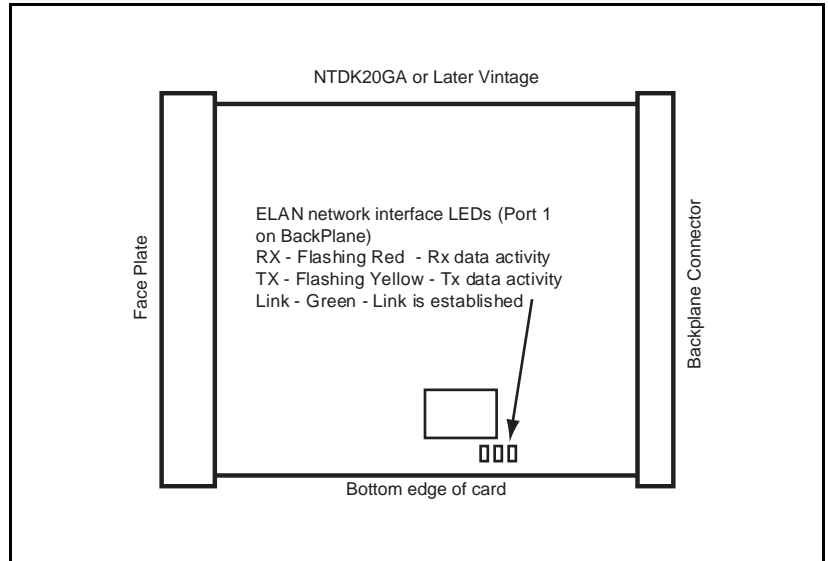
**Figure 11**  
**ELAN network interface LEDs on SSC**

The NTDK20 SSC card also has three LEDs to indicate the status of the ELAN network interface. See Figure 11 on [page 53](#) for the location and a description of the LEDs.

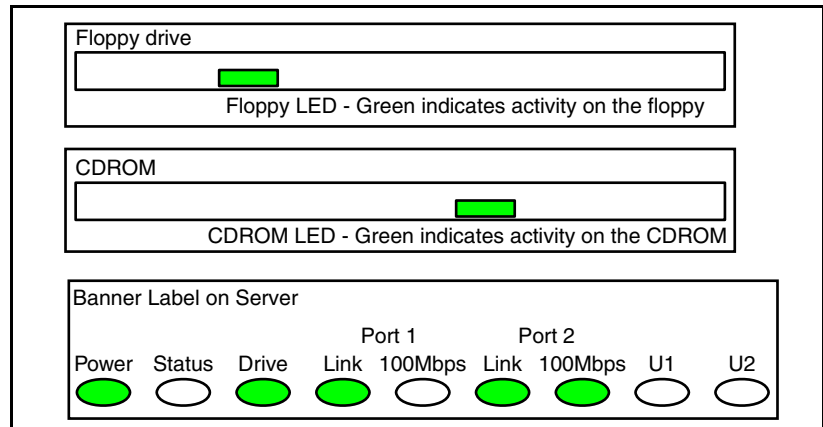
**Figure 12**  
**Signaling Server LEDs**

Refer to Figure 12 on [page 54](#) and the following for the status of the Signaling Server LEDs:

- 100 Mbps – Green LED indicates the network interface Port 0 or Port 1 is running at 100Mbps. Off indicates 10Mbps.
- U1 and U2 are not used.

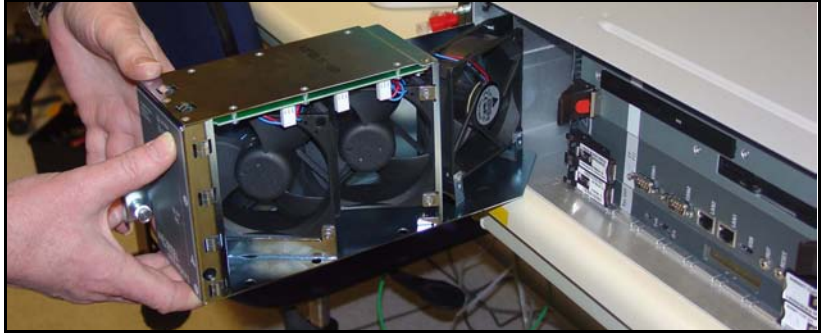
**Figure 13**  
**Alarm/fan module**

- 1 Unhook the locking devices on the alarm/fan module.
- 2 Pull the alarm/fan module out of the Call Server. (See Figure 13 on [page 131](#)).

- 3 Insert the replacement alarm/fan module into the vacated slot and hook the locking devices.
- 4 Use a Phillips screwdriver to tighten the screws on the alarm/fan module.

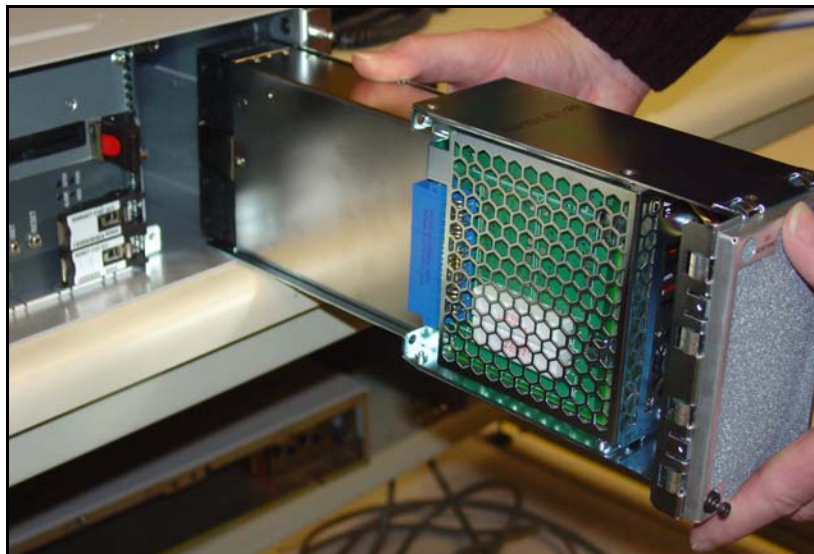
**Figure 14**  
**Power supply module**

- 5    Pull the power supply out of the Call Server. (See Figure 14)

- 6    Before you insert the power module into the Call Server, configure the power supply switch on the rear of the module to OFF (down).
- 7    Insert the replacement power supply into the vacated slot and ensure it is well-seated.
- 8    Use a Phillips screwdriver to tighten the locking screw on the power supply.
- 9    Reattach the power cord at the rear of Call Server and reconnect to the power source. Turn on power to the power supply module.
- 10   Tag defective equipment with a description of the problem, and package it for return to a repair center.

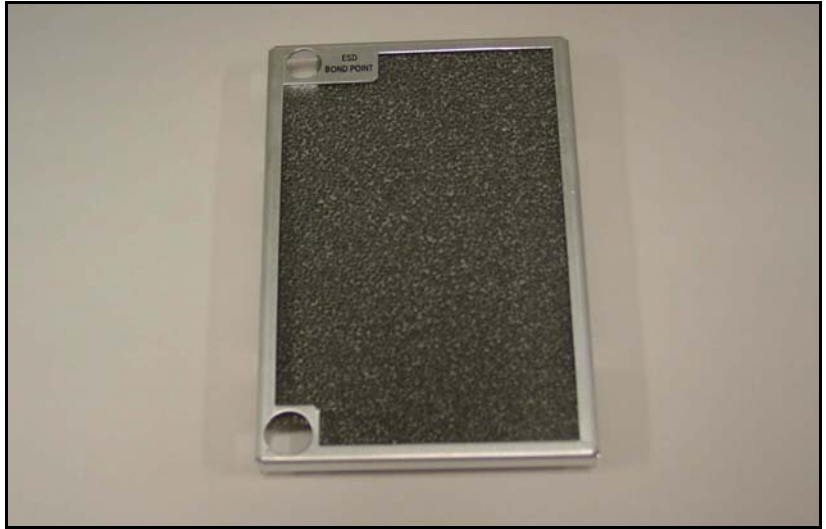
**Figure 15**  
**CS 1000E power supply air filter**

Figure 15 shows the Call Server power module air filter (P06094950). It consists of one aluminium frame and foam insert. The air filter foam kit (N0003712) contains ten replacement foam inserts.

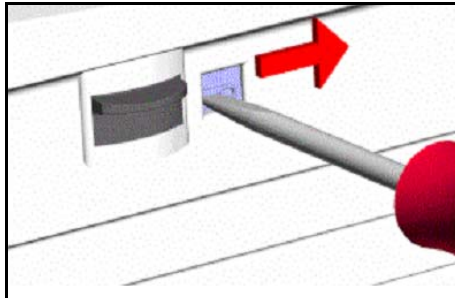
**Figure 16**  
**Inserting screwdriver in slot**

- 1 If the front cover lock latches are in their locked position, use a flat screwdriver to slide the icon away from the latch. Refer to Figure 16.

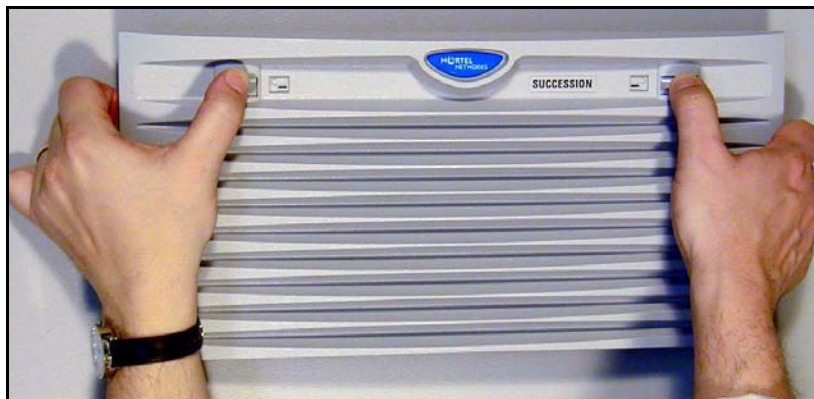
**Figure 17**  
**Depressing latches and pulling back on front cover**

- 2 Simultaneously slide both spring-loaded latches toward the bottom of the cabinet and pull forward. Then lift the cover upward to remove it from the cabinet. Refer to Figure 17 on [page 136](#).

**Note:** The bottom of the front cover is supported but not secured to the cabinet. Be careful not to drop it.
