OHAS — Off-Hook Alarm Security

OSM — Operating System Messaging

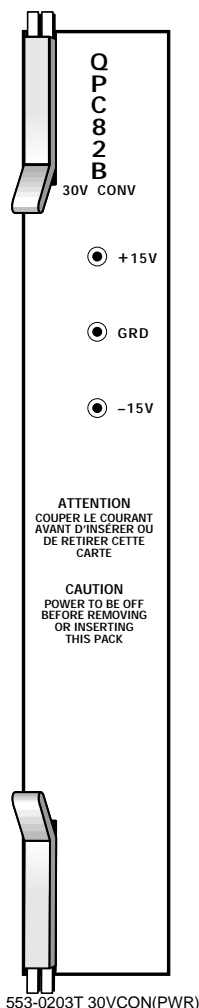
30V CONV — Thirty volt converter

The QPC82 30V converter converts -48V dc to ± 15 V dc supplies for Meridian 1 proprietary telephones.

The QPC82 card is adjusted at the factory to provide adequate voltage. Field testing is not required unless a complete failure is suspected. If the measured voltage is zero, the card needs to be replaced. Any voltage greater than zero indicates the card is fully operational, and within the approved operating specifications.

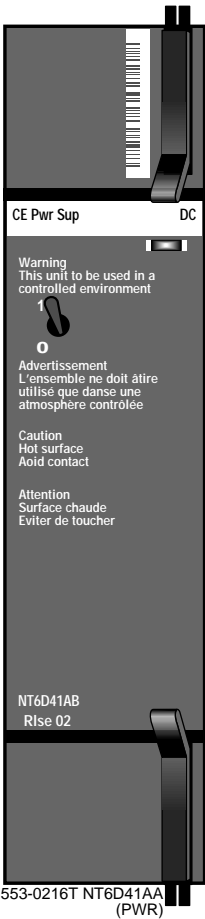
Common Equipment Power Supply (DC)

The NT6D41AA Common Equipment power supply DC is used with System Options 61 and 71.
