Meridian 1

Software Input/Output Guide

X11 System Messages

Document Number: 553-3001-411

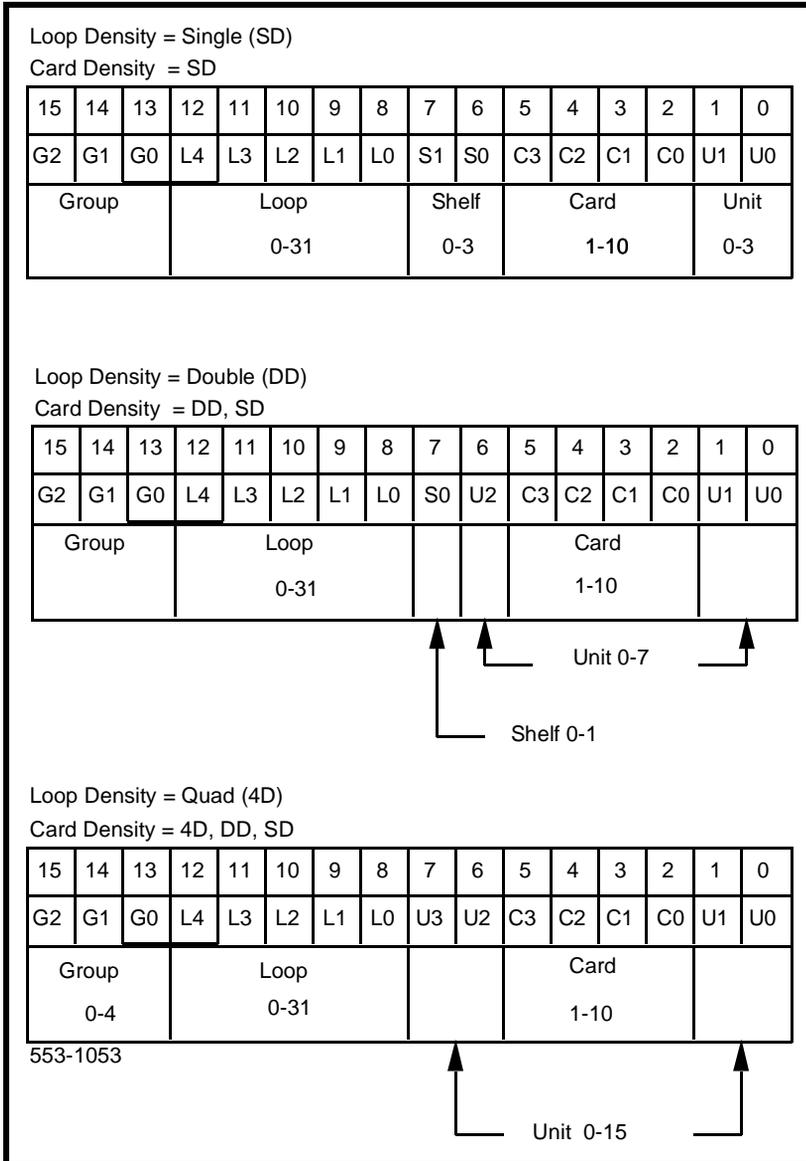
Figure 1
Terminal number formats

HEX	0	1	2	3	4	5	6	7	8	9	A	B	C	D	E	F
Binary	0000	0001	0010	0011	0100	0101	0110	0111	1000	1001	1010	1011	1100	1101	1110	1111
Decimal	0	1	2	3	4	5	6	7	8	9	10	11	12	13	14	15

2. Decode the binary number using the formats shown in Figure 1. In this example, the TN is single density.
