EDD — LD 43 Equipment Data Dump

How the EDD works

The LD 43 Equipment Data dump (EDD) is used to keep data on the system storage device up-to-date. When data dump is invoked, data in the read/write memory (including any that has been changed or added) is written to the storage device at the location reserved for it.

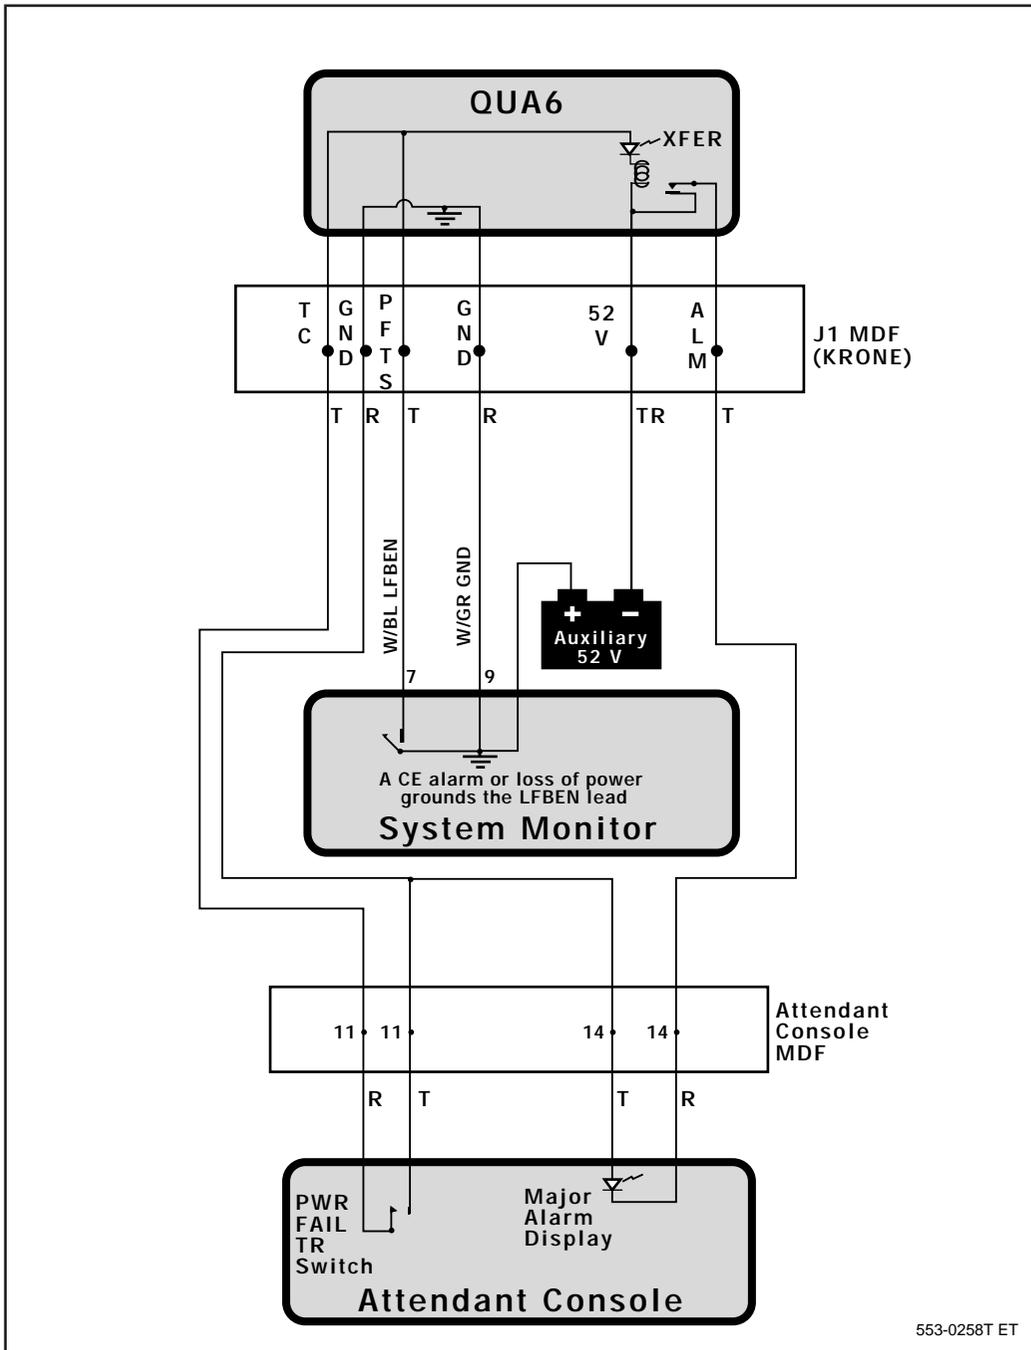
Option 21 to 81C using a QUA6 unit

The diagrams show the connections to the control circuits for the QUA6 and NT8D39 units. The trunk and line connections for these units are found in the Installation NTP.

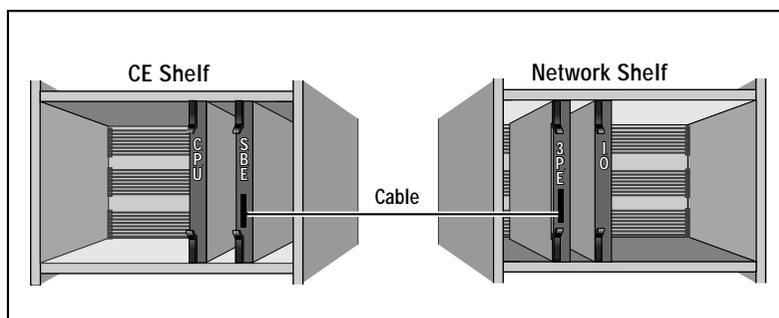
553-0186T SI

The CPU or FN tried to access an I/O device port but could not because of a faulty extender (SBE, 3PE, cable). The CPU is unable to indicate which extender is at fault. It can only indicate that the I/O device it tried to access did not respond. The I/O device is indicated in the faceplate **hex** display or this message **hex** code .

1. If there is no hex indicator, the standby CPU has full access through the extenders to the network shelves but the active CPU does not.

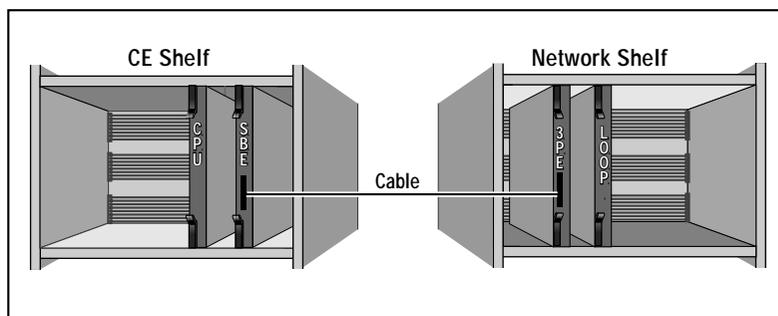
553-0187T SI

The CPU or FN tried to access a Network, Tone and Digit switch, or conference loop, but could not because of a faulty extender (SBE, 3PE, cable). The CPU is unable to indicate which extender is at fault. It only indicates that the loop it tried to access did not respond. The loop is shown in the faceplate **hex** display or this message **hex** code .

1. If there is no hex indicator, the standby CPU has full access through the extenders, to the network shelves, but the active CPU does not.

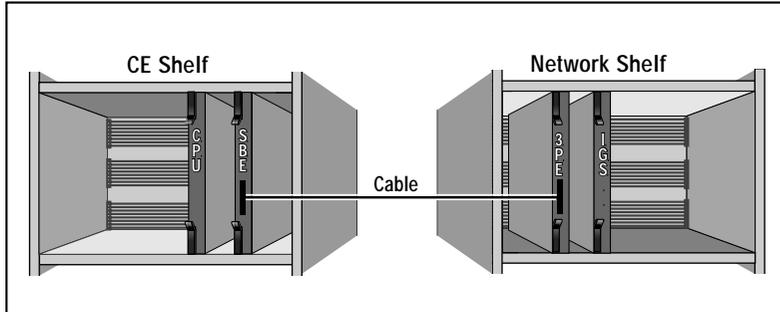
553-0188T SI

The CPU or FN tried to access an Intergroup Switch card but could not because of a faulty extender (SBE, 3PE, cable). The CPU is unable to indicate which extender is at fault. It can only indicate that the IGS card it tried to access did not respond. The IGS card is indicated in the faceplate **hex** display or this message **hex** code .

1. If there is no hex indicator, the standby CPU has full access, through the extenders, to the network shelves but the active CPU does not.

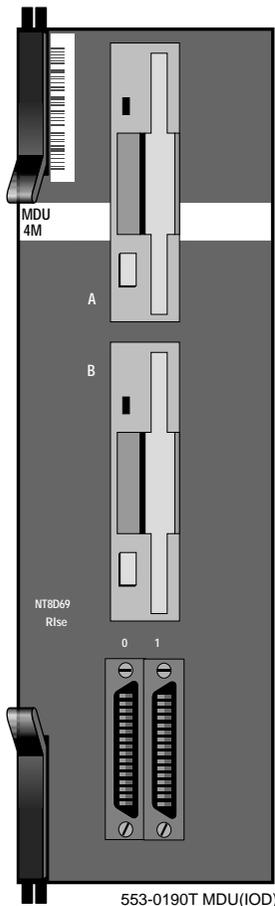
MDU — Multi Disk Unit

The Multi Disk Unit (MDU) is used to load the programs and programmable data into the system memory.

The mass storage system is used as the nonvolatile storage medium and consists of two 3.5 inch floppy disk drives, a mass storage interface card, and a hard disk drive (optional).

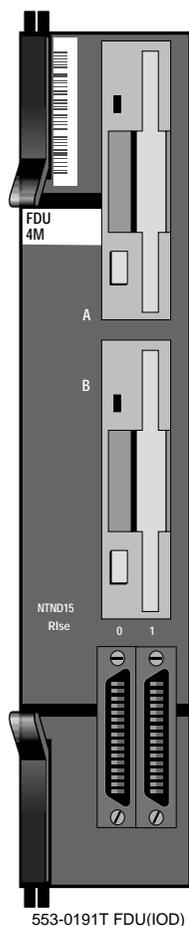
553-0191T FDU(IOD)

FDU — Floppy Disk Unit

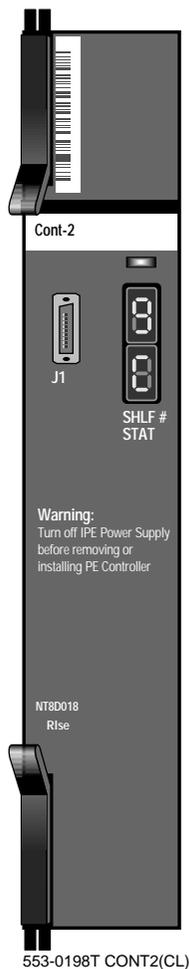
553-0198T CONT2(CL)

Cont 2/4 — Peripheral Equipment Controller

The Peripheral Equipment Controller (PEC) is available in two versions: the PEC2, which will control up to two Superloop cards and the PEC4 which will handle up to four Superloop cards. Both versions use the same printed circuit board, with the PEC2 having a partially populated board and the PEC4 using a fully assembled board.
